# REPORT ON A WATER POLLUTION SURVEY OF THE TOWNSHIP OF SANDWICH WEST COUNTY OF ESSEX

may, 1973

Ministry  
of the  
Environment

DISTRICT ENGINEERS SECTION  
SANITARY ENGINEERING BRANCH  
DIVISION OF WATER SUPPLY AND POLLUTION CONTROL

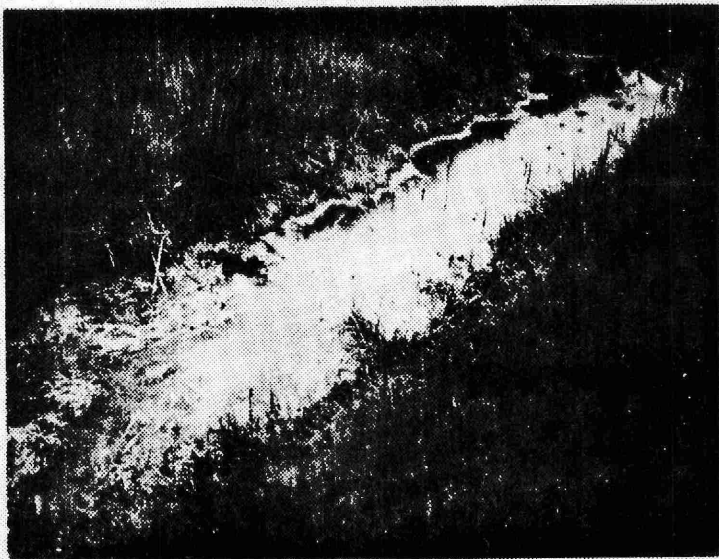
PHOTO # 3

LOCATION POINT # 52

FECAL COLI - 700,000 / 100 ML

TOTAL COLI - 170,000,000 / 100 ML

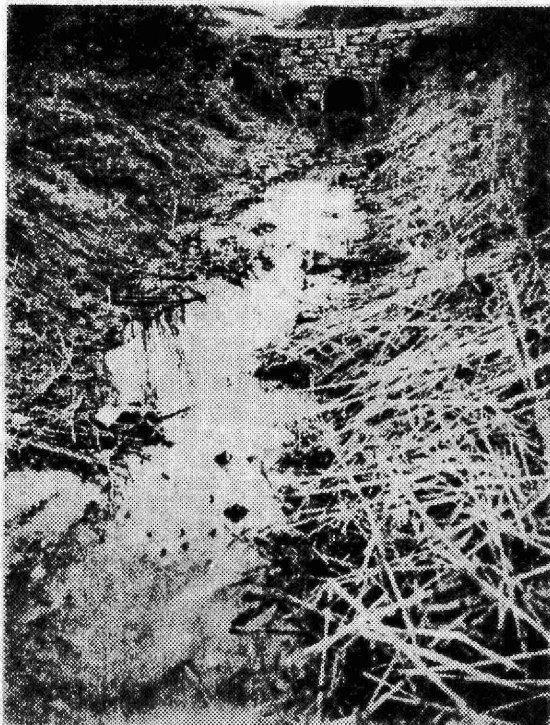
PHOTO # 11

LOCATION POINT # 73

LEPAIN DRAIN AT MONTGOMERY ROAD

NOTE: DISCOLORATION AND SEWAGE FUNGUS

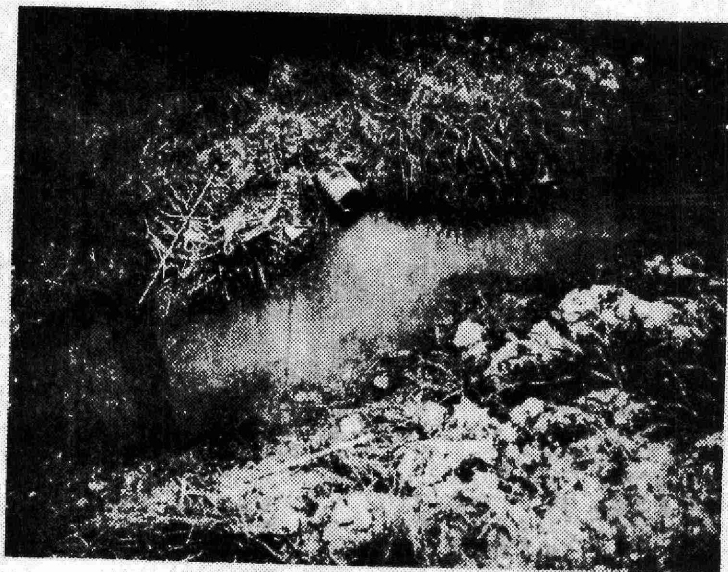
PHOTO # 15

LOCATION POINT # 76

NEAR BROOKLYN AVE.

NOTE: HOUSE CONSTRUCTION
